Manhole Inspection Summary

Manhole # S47E__015MH

Location Address: **Patterson Park**

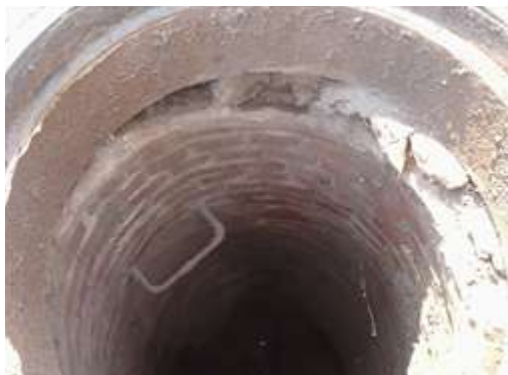
Defect 2

Condition: ☐ Sound ☐ Cracked ☐ Root Intrusion ☒ **Loose Brick** ☐ Deteriorated

loose brick

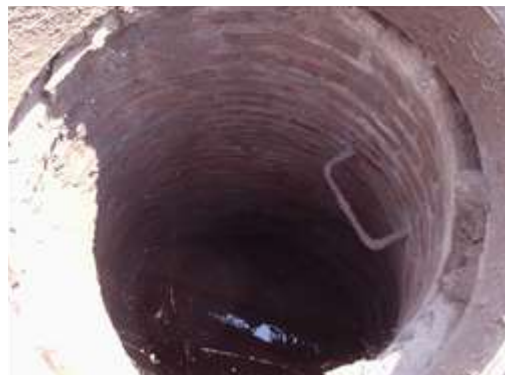
Defect 1

deterioration

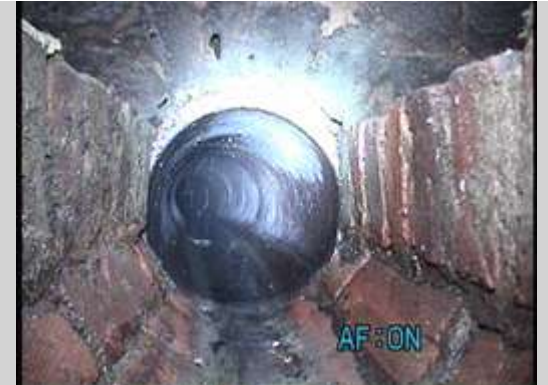
12 O'Clock Outflow

8 in. Circular Gravity Sewer
Pipe Out @ 12 O'Clock

Pipe Height: **8.4** (in.) Rod and Bar (Angled)
Pipe Material: **Clay** ☐ Pipe Lined
Invert Depth: **10.45** (ft.) Flow Characteristics: **Slow**
Deposits: ☒ None ☐ Mud ☐ Sludge ☐ Debris ☐ Grease
Silt Depth: (in.) Deposits Extent:
Infiltration: **None** Pipe Seal Cond: **Sound**

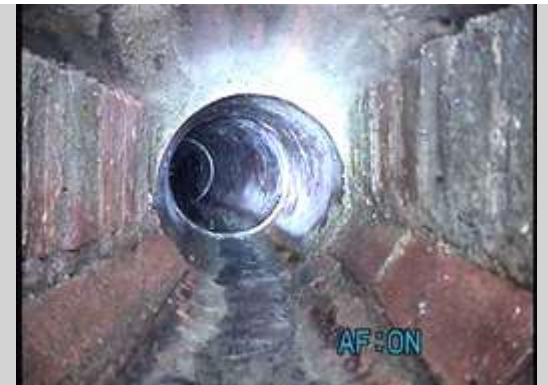
6 O'Clock Inflow

8 in. Circular Gravity Sewer
Pipe In @ 6 O'Clock

Pipe Height: **8.4** (in.) Rod and Bar (Angled)
Pipe Material: **Clay** ☐ Pipe Lined
Invert Depth: **10.40** (ft.) Flow Characteristics: **Slow**
Deposits: ☒ None ☐ Mud ☐ Sludge ☐ Debris ☐ Grease
Silt Depth: (in.) Deposits Extent:
Infiltration: **None** Pipe Seal Cond: **Sound**
